RESULTS OF TESTS

COLLECTIVE PORTLAND CEMENT
EXHIBIT AND MODEL TESTING
LABORATORY OF THE ASSOCIATION
OF AMERICAN PORTLAND CEMENT
MANUFACTURERS. :: :: :: :: ::

LOUISIANA PURCHASE EXPOSITION
St. Louis, Mo.
1904.

RICHARD L. HUMPHREY, M. Am. Soc. C. E.

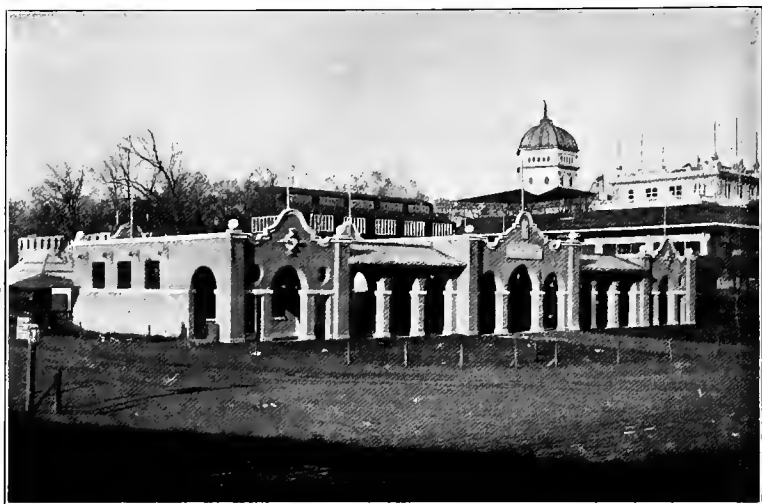
FIG. 1.—General View of Building.

The exhibit building, one of two permanent structures, which has been presented to and accepted by the Park Commission of the City of St. Louis, Mo., is an excellent example of reinforced

concrete construction, and consists of three pavilions separated by intermediate courts and connected across the front by a continuous loggia, the roof of which is covered with cement tiling (Spanish pattern) of a rich red color. This coloring, together with the red tinting of the ceiling of the loggia, relieve the general grey tone of the walls and forms an agreeable color contrast. The style, Spanish Mission, and the rough-finished walls are particularly well adapted to the use of concrete.

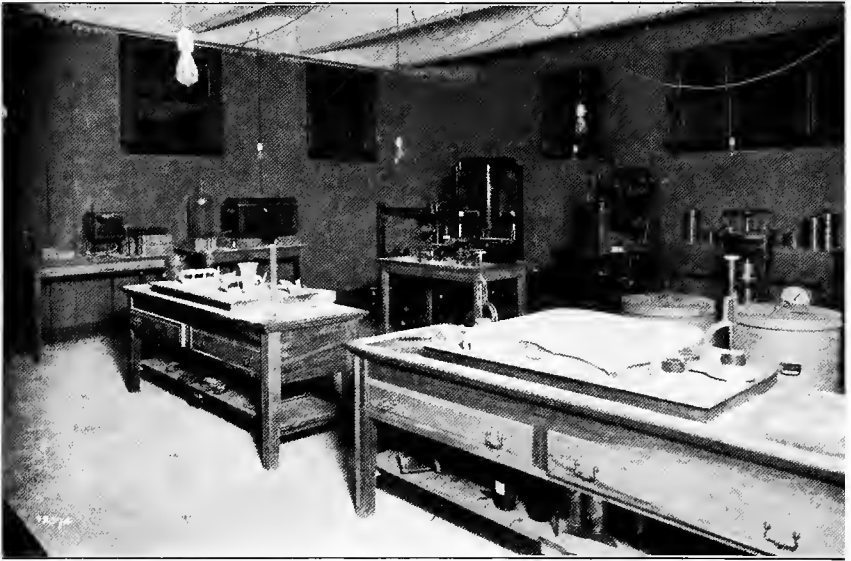
FIG. 2.—General View of Laboratory.

The central pavilion contained a thoroughly modern and admirably equipped testing laboratory, the finest that has ever been installed in this country. This laboratory was in daily operation, demonstrating the methods used for testing cement and concrete.

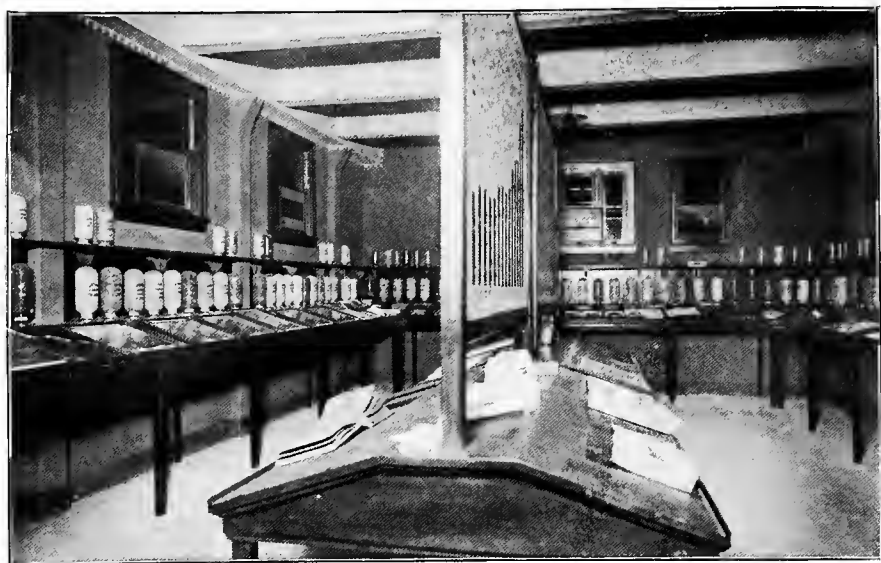
FIG. 3.—View of Cement and Concrete Materials Exhibit

The various forms of metal used in reinforcing concrete, the sand, gravel, cinders, and broken stone, from all over the country, were on exhibition. Besides, there was a collection of photographs of work built of concrete, from all over the world, and of tests made to establish the fire-resisting qualities of concrete.

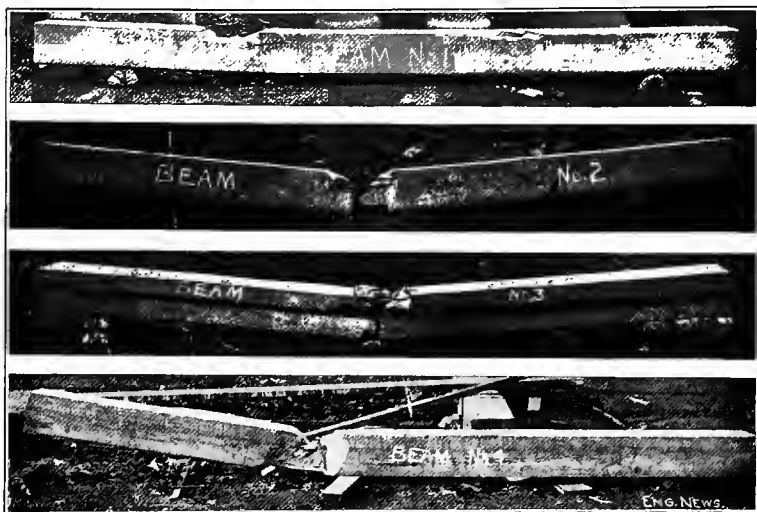
FIG. 6.—Views of Reinforced Concrete Beams 1, 2, 3 and 4 After Failure.

Fig. 6 shows the condition of the beams after testing; the photographs are not, however, sufficiently clear to show the location of the hair cracks. The poor quality of the concrete which will be alluded to later, caused the beams to fail without developing the full strength of the steel in tension, although in both the Hennebique and Kahn beams the compressive resistance of the top of the beam was materially increased by the steel reinforcement. In the latter beam the results would probably have been higher had the top reinforcing bar run the full length of the beam, as it will be observed that the concrete failed around the ends of this bar.

In addition to the above tests, four experimental beams were tested in the laboratory; three of these (two of rectangular and one of T-section) were made according to the Hennebique system; and the other, also rectangular in section, according to the Kahn system. The beams of rectangular section were made under identical conditions and were designed to carry the same load using the same percentage of steel reinforcement. These beams were made in the open air and were not wetted after being made

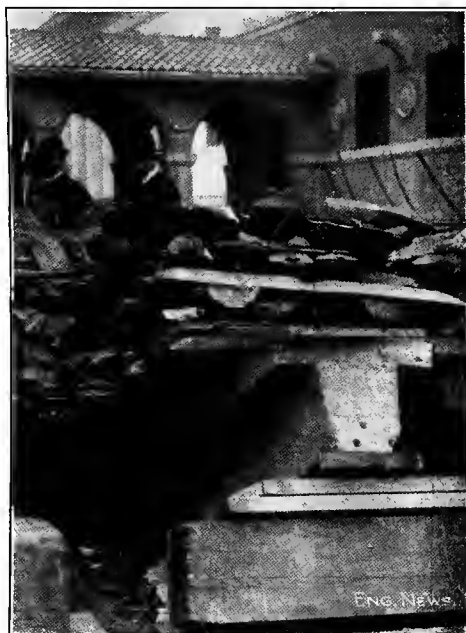
Bars sliding as beam collapsed, Fig. 7. The slab sheared off on one side as will be seen, this was probably due to lack of uniformity of

FIG. 7.—View of End of Beam E Showing Shearing Off of Slab and Sliding of Reinforcing Rods.

load. The bars did not slip until the beam collapsed. There was no reinforcing in the slab. The dimensions of beam and other information can be obtained from Fig 8, page 24.

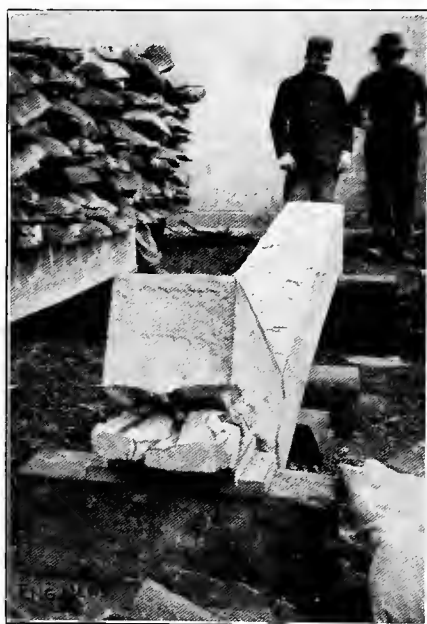
A series of vertical cracks appeared until the beam failed suddenly by horizontal shear at one end entirely. Bars again slipped as beam collapsed. Dimensions of beam given in Fig. 8, page 24. Fig. 9 shows beam after failure.

FIG. 9.—View of End of Beam E Showing Sliding of Reinforcement.

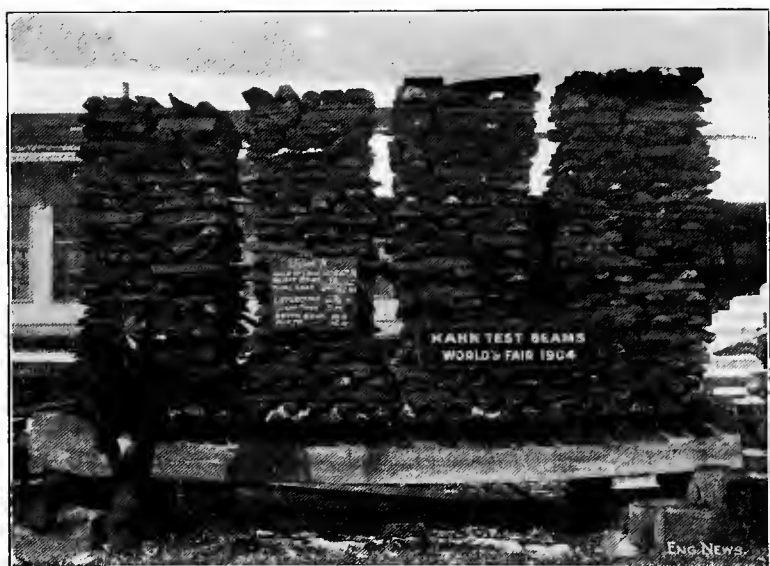
FIG. 10.—View of Kahn Beam A Under Load

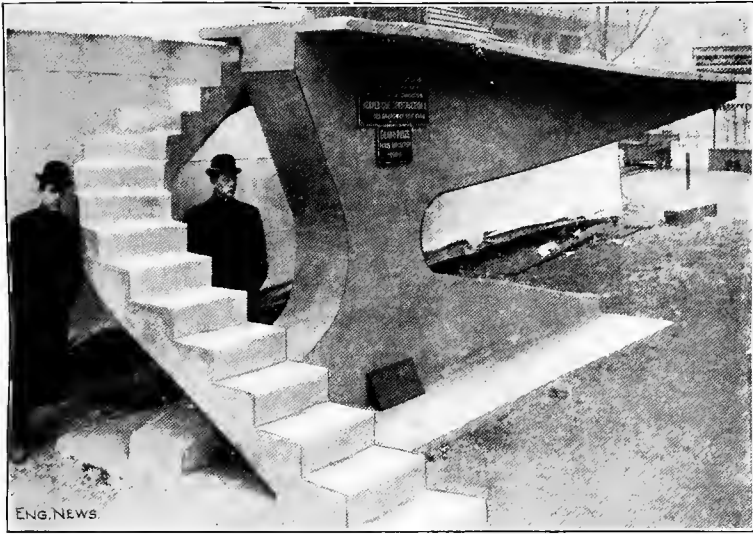
Cantilever.—This is shown in Fig. 12 and was built to illustrate the flexibility of reinforced concrete, the dimensions and rein-

FIG. 12.—View of Reinforced Concrete Cantilever Tested to Destruction.

The cantilever was built, as was discovered afterwards, over a wooden box drain and the settlement of the foundation caused the cantilever to tilt towards the outer end.

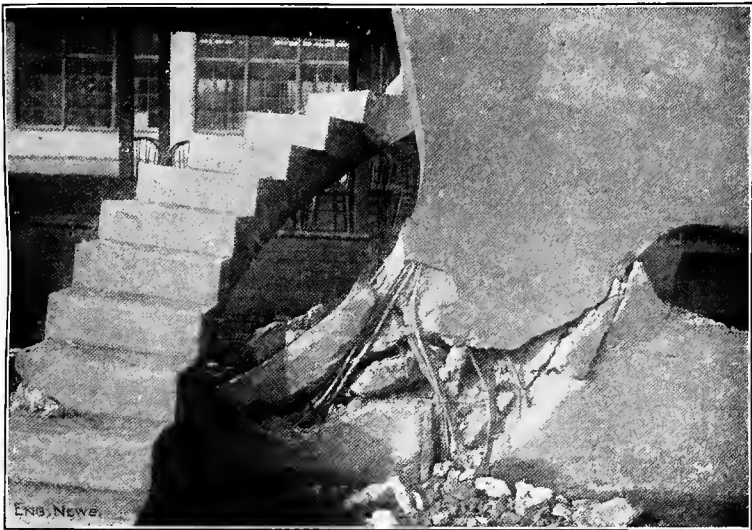
FIG. 16.—View Showing Failure of Reinforced Concrete Cantilever

apart at the left shank and failed as shown in Fig. 16 before the compressive resistance of the concrete in the right center section of the shank had been reached. The loading was as follows:

cement. The props were then gradually removed and the cantilever remained unchanged until tested with pig iron. The application of this load caused the cracks to open at left side of shank and the cantilever collapsed. As bars of the requisite size were not available a bundle of smaller rods was substituted; the shear members were insufficient to hold the cantilever and it pulled

Loads. lbs.	Deflection. in.	Remarks
3060	1-16	
9845	1-4	
13735	11-32	
14760		Hair crack appeared.
17680	1-8	Opening at center 11-16 in. at outer end.
20607		Failed 4-11-16 in. extension at the center.
